# Infrared Inspection for Pacific Crest Company

**Site: Chicago Plant  
821 – 33<sup>rd</sup> Avenue  
Chicago, IL 60601**

**February 20, 2004**

# Infrared Inspection Report

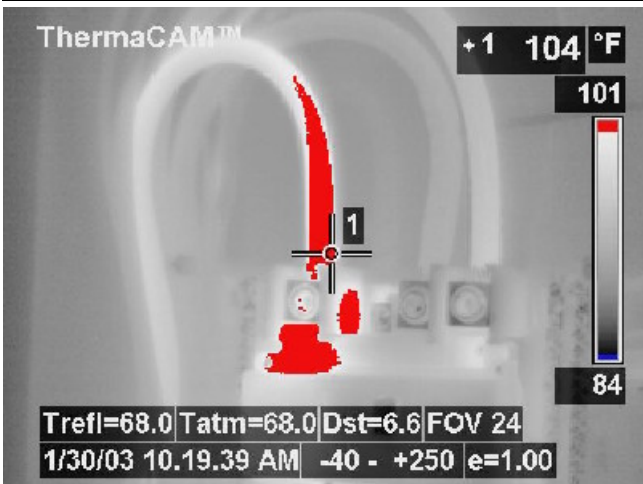
IR Image: IR\_0036.jpg  
 Photo: DC\_0037.jpg

Asset ID:                      Barcode:  
 Location: Main Building  
                   1 Floor  
                   Main Electrical Vault  
                   Main Switchboard

Problem	Reference	Temperature Difference	Ambient Temperature
A Phase: 165 F	C Phase: 110 F	55 F	78

A Phase: 25                      Neutral:  
 C Phase: 25                      Rated Load: 100  
    % Rated Load: 25

A Phase line side wire lug connection on circuit breaker - 100 amp

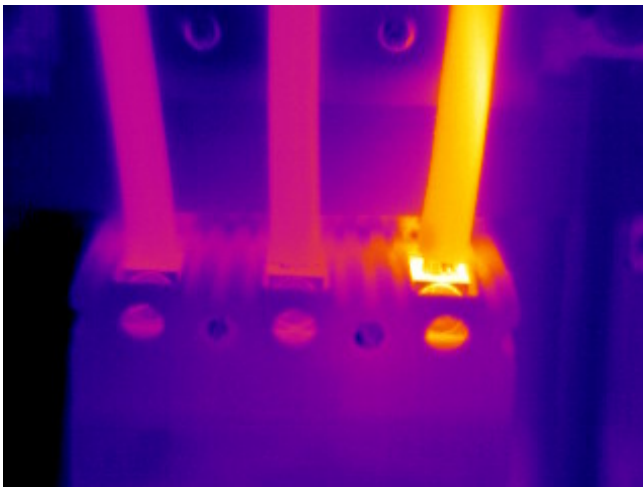
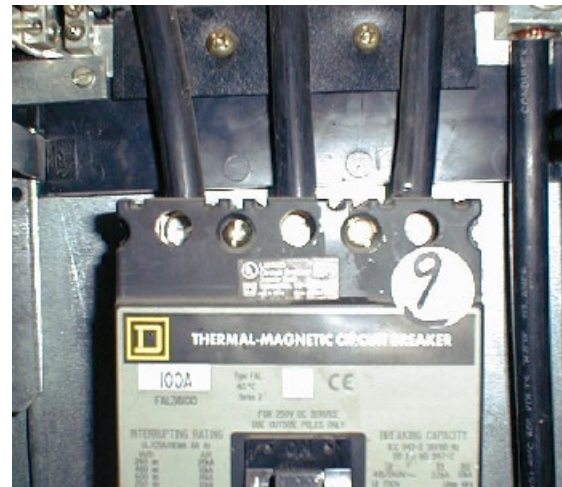
IR Image: IR101.bmp  
 Photo: Ph101a.jpg

Asset ID:                      Barcode:  
 Location: Building A  
    electrical panel

Problem	Reference	Temperature Difference	Ambient Temperature
A Phase: 88 F	C Phase: 75 F	13 F	68

C Phase line side wire lug connection on circuit breaker - 100 amp

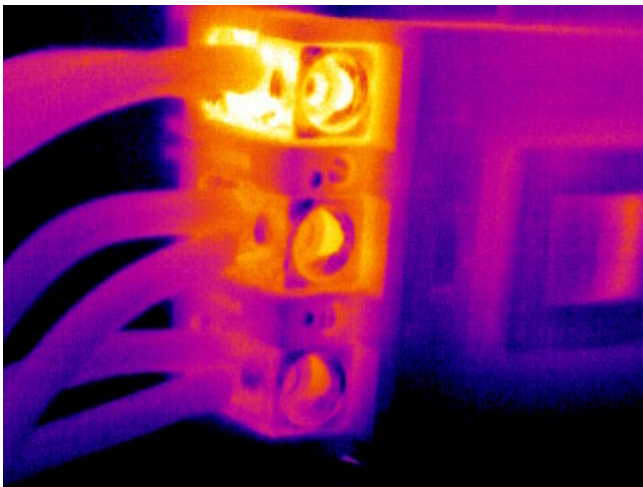
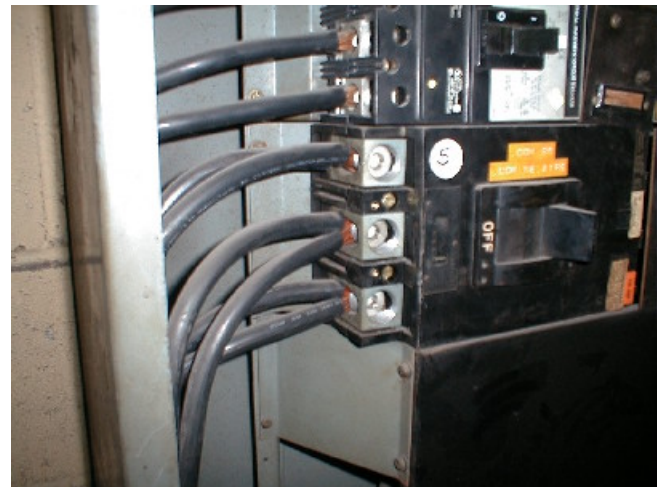
IR Image: B0213-05.bmp  
 Photo: 12020014.JPG

Asset ID:                      Barcode:  
 Location: West Tower  
                  3 Floor West  
                  Electrical Room WT-3  
                  Electrical Room WT L3-1

Problem	Reference	Temperature Difference	Ambient Temperature
A Phase: 125 F	B Phase: 98 F	27 F	68

A Phase load side wire lug connection on circuit breaker - 100 amp 765675675

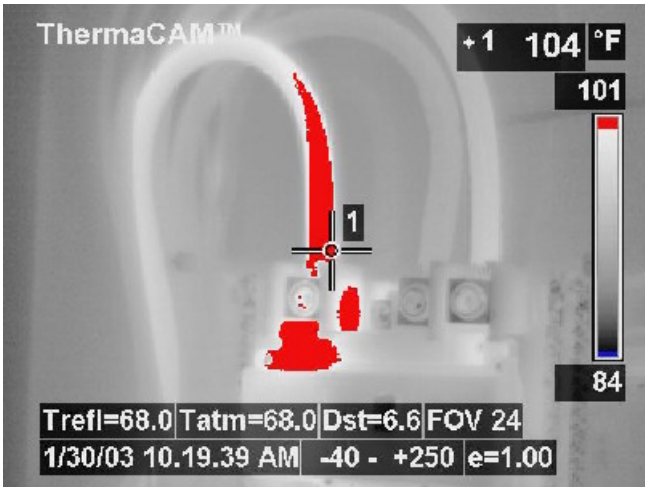
Infrared Filename	Infrared Date	Photo Filename	Photo Date
IR_0036.jpg	4/27/2012	DC_0037.jpg	8/27/2003

Problem	Reference	Temperature Difference
A Phase: 165 F	C Phase: 110 F	55 F

**Problem:** A Phase line side wire lug connection on circuit breaker - 100 amp

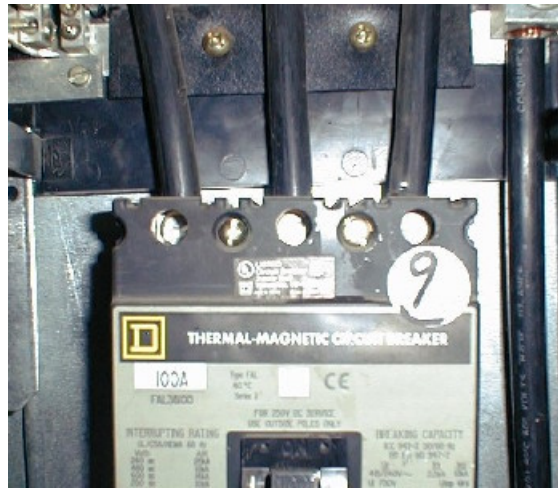
<b>Infrared Filename</b>	<b>Infrared Date</b>	<b>Photo Filename</b>	<b>Photo Date</b>
IR101.bmp	2/13/2001	Ph101a.jpg	4/27/2012

<b>Problem</b>	<b>Reference</b>	<b>Temperature Difference</b>
A Phase: 88 F	C Phase: 75 F	13 F

**Problem:** C Phase line side wire lug connection on circuit breaker - 100 amp

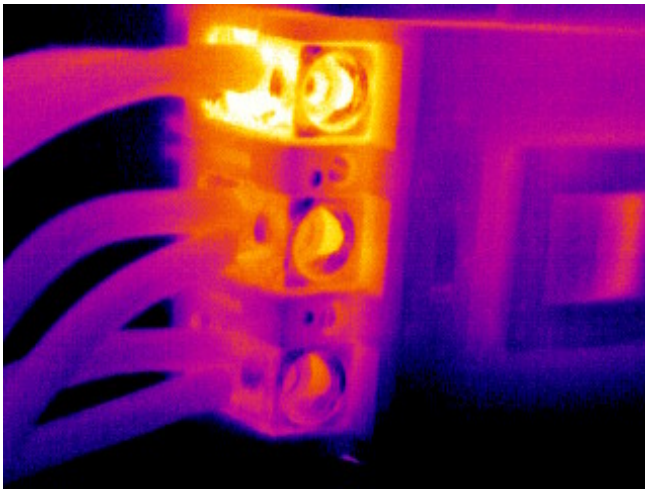
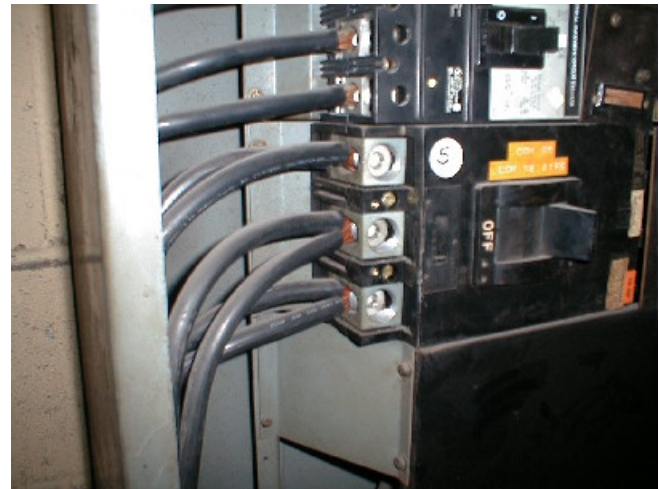
Infrared Filename	Infrared Date	Photo Filename	Photo Date
B0213-05.bmp	2/13/2001	12020014.JPG	12/2/2001

Problem	Reference	Temperature Difference
A Phase: 125 F	B Phase: 98 F	27 F

<b>Problem:</b> A Phase load side wire lug connection on circuit breaker - 100 amp 765675675	
<b>Recommendation:</b>	
<b>Repaired By:</b>	<b>Repair Date:</b>
<b>Repair Notes:</b>

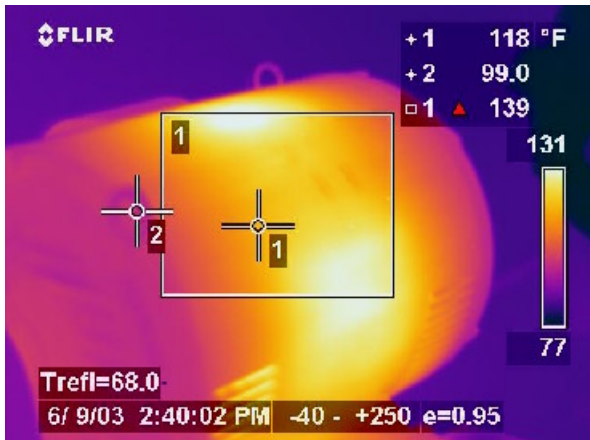
IR\_060903\_003.jpg

Equipment Location: Main Building \ 1 Floor \ Mechanical Room \ Main Chill Water Pump Motor

Inspection No	Date Inspected	Test Status	Measured Temp	Threshold Temp	Ambient Temp	Status Note	Customer Notes
1001	2/19/2004	TESTED	118 F	150 F	75 F		
1002	2/19/2004	NTTC	126 F	150 F	77 F		
1003	2/19/2004	TBT	147 F	150 F	77 F		
1004	3/1/2007	TESTED	176 F	150 F	80 F
